T B 1 2 5 7

TOYOTA HILUX KUN26 & PRADO KDJ150 REMAN INJECTORS WITHOUT VISIBLE CALIBRATION CODE

12 AUGUST 2024

MODELS: TOYOTA HILUX KUN26 AND PRADO KDJ150 FITTED WITH 1KDFTV ENGINE 11/2009 ONWARDS.

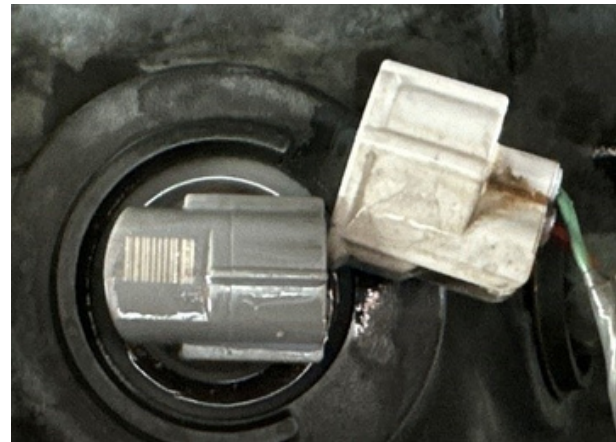
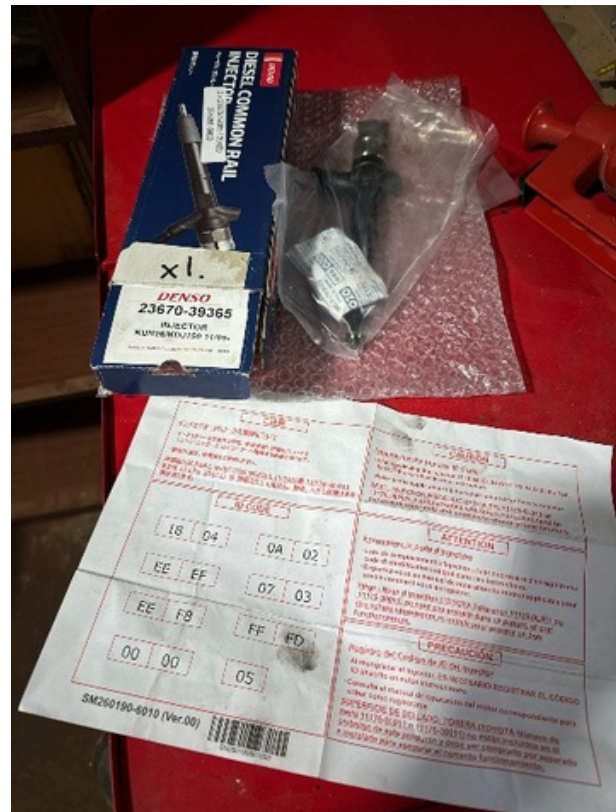
The top of the injector is labelled with a barcode and no numbers. The injector calibration codes are only available on the piece of paper in the original packaging whereas normally the code is located on the top section of the injector solenoid. This will become a problem when the injector is removed and re-install in the engine.

It has been reported that these injectors are remanufactured from of the original and were only meant for the Asian market. They have now been made available in Australia by the injector manufacturer Denso. We are unsure why, but from what we know, they only operate when they are fitted as a matched set.

We strongly advise that if you do decide to install remanufactured injectors, make sure that you purchase the full set from a reliable supplier. Do not mix these injectors with the genuine manufactured injectors.

Advise only supply and install injectors with the calibration coding on the injector.
